S3900 SERIES SWITCHES TECHNICAL WHITE PAPER

AFTER-SALE INSTRUCTIONS FOR ERROR-PRONE ISSUES

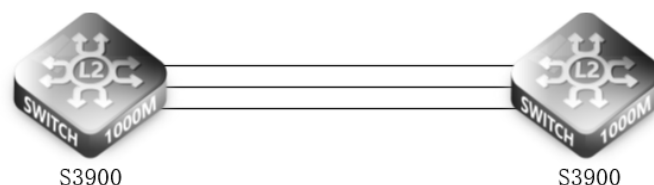
1.2 Topology Information

The issue of LINK AGGREGATION function of the S3900 series switches. It cannot directly create a LINK group when configuring the LINK AGGREGATION dynamic mode. It needs to be added to the group directly in the port mode of the interface. The static LINK AGGREGATION function is to create the LINK group first. Add group members to the group in port mode.

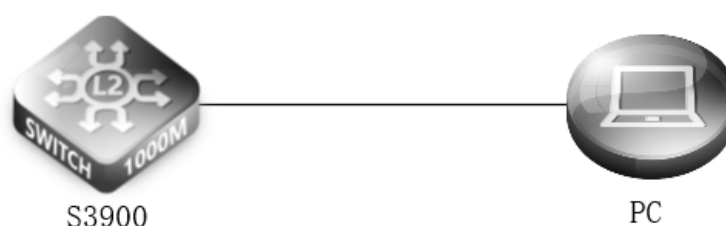
2.2 Topology Information

The issue of SSH function of the S3900 series switches. RSA can only import the V1 key, but cannot import the V2 key. The V1 key has low security. When the number of public key is larger than 2048 bytes, the import fails. When the public key is generated, if Subject: Administrator needs to be deleted, the switch cannot recognize Subject: Administrator. If the generated public key is "Comment" is "注释", change "注释" to "Comment", the switch does not recognize Chinese, "注释" needs to be manually changed to "Comment".

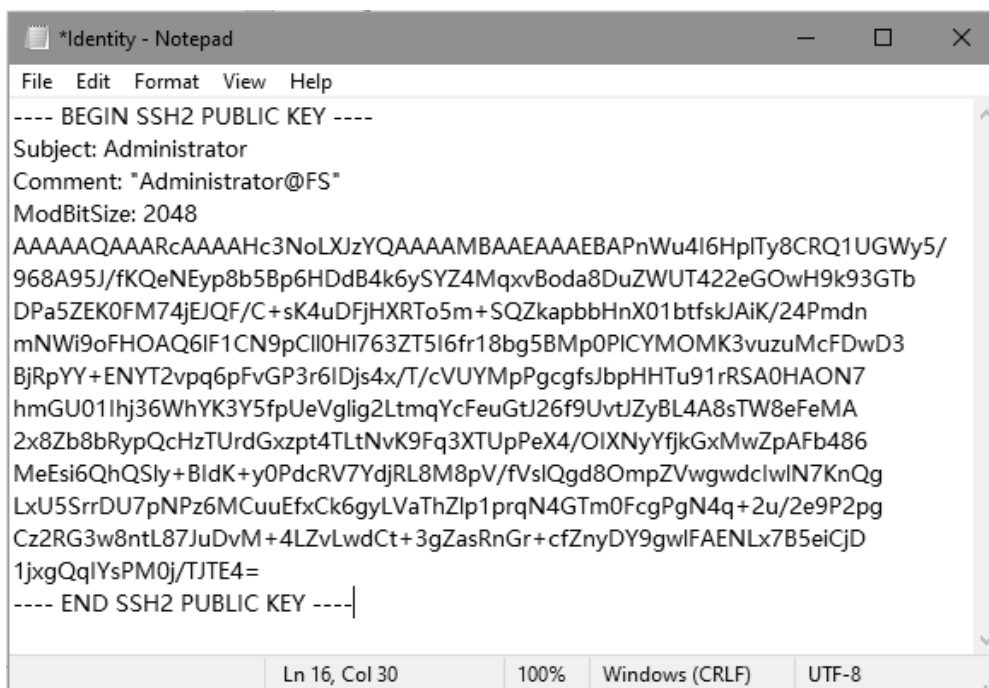
4. If there is a Subject: Administrator in the generated public key, you need to delete it before uploading it to the device. The S3900 series switches cannot recognize the Subject: Administrator.

If the "Comment" in the generated public key is "注释", change the "注释" to "Comment", the switch does not recognize Chinese, and the "注释" needs to be manually changed to "Comment".

```
*Identity - Notepad
File Edit Format View Help
---- BEGIN SSH2 PUBLIC KEY ----
Subject: Administrator
Comment: "Administrator@FS"
ModBitSize: 2048
AAAAAQAAARcAAAAHc3NoLXJzYQAAAMBAEAAAEBAPnWu4I6HpITy8CRQ1UGWy5/
968A95J/fKQeNEyp8b5Bp6HDdB4k6ySYZ4MqxvBoda8DuZWUT422eGOwH9k93GTb
DPa5ZEK0FM74jEJQF/C+sK4uDFjHXRT05m+SQZkapbbHnX01btfskJAiK/24Pmdn
mNW9oFHOAQ6IF1CN9pCII0HI763ZT5I6fr18bg5BMp0PICYMOMK3vuzuMcFDwD3
BjRpYY+ENYT2vpq6pFvGP3r6lDjs4x/T/cVUYMpPgcgfsJbpHHTu91rRSA0HAON7
hmGU01lhj36WhYK3Y5fpUeVglig2LtmqYcFeuGtJ26f9UvtJZyBL4A8sTW8eFeMA
2x8Zb8bRypQcHzTUrdGxzpt4TLtNvK9Fq3XTUpPeX4/OIXNyYfjkGxMwZpAFb486
MeEsi6QhQSly+BlDK+y0PdcRV7YdjRL8M8pV/fVslQgd8OmpZVwgdclwlN7KnQg
LxU5SrrDU7pNPz6MCuuEfxCk6gyLVaThZlp1prqN4GTm0FcgPgN4q+2u/2e9P2pg
Cz2RG3w8ntL87JuDvM+4LZvLwdCt+3gZasRnGr+cfZnyDY9gwIFAENLx7B5eiCjD
1jxgQqIYsPM0j/TJTE4=
---- END SSH2 PUBLIC KEY ----
Ln 16, Col 30 100% Windows (CRLF) UTF-8
```

To sum up, when the S3900 series switches use RAN of SSH to import the V2 key, the maximum public key of the S3900 series only supports 2048 bytes due to the limitation of the public key bytes. Another problem is the public key format, the S3900 series switches does not recognize the "Subject : Administrator" and "Comment" are Chinese.

Check the format of the public key and remove the Chinese annotations and the words "Subject: Administrator" when generating the public key.

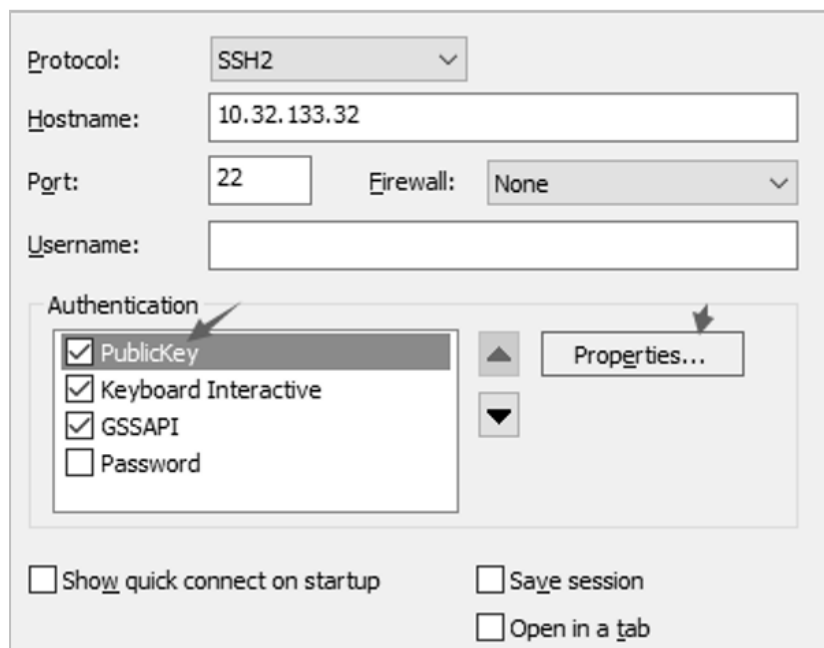
5. Use the CRT software to select the private key generated by the connection to log in to the device.

Protocol: SSH2

Hostname: 10.32.133.32

Port: 22 Firewall: None

- ☒ PublicKey
- ☒ Keyboard Interactive
- ☒ GSSAPI
- ☐ Password

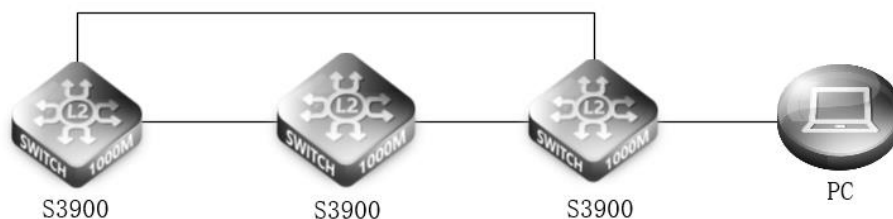
3.2 Topology Information

The issue of the stacking function of S3900 series switches. After the stacking function is used, the configuration is saved during the stacking period. If the master device is decoupled first and the stacking line is not pulled out, the configuration file of the slave switch is not restored to the configuration before the stack, but the configuration file during the stack is maintained.

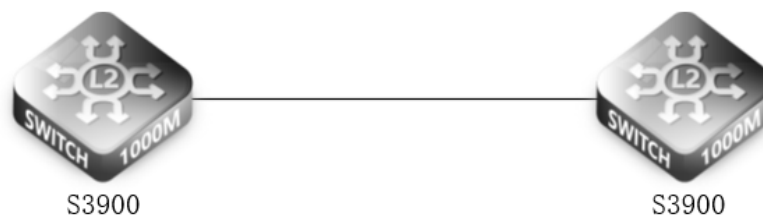
4.2 Topology Information

The issue of DAC cable connectivity of the S3900 series switches. When S3900-48T4S series switches do not enable port negotiation, a 5 meter DAC cable port will not be LINK UP.
